## 2010 BMW X1 mileage Repair, CGPRO one-step fix!!!!

Car Model: BMW X1 (imported version)

Year: 2010 model

Operation: mileage repair

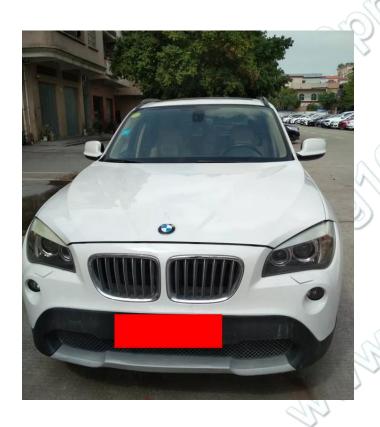
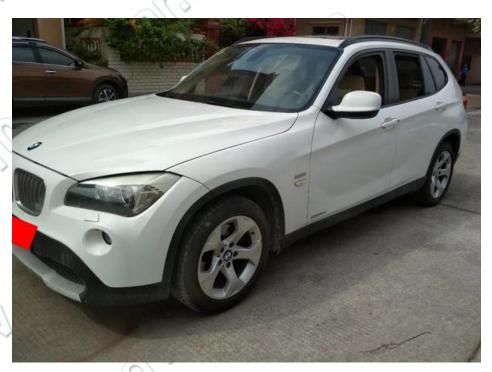
1. View specific models.

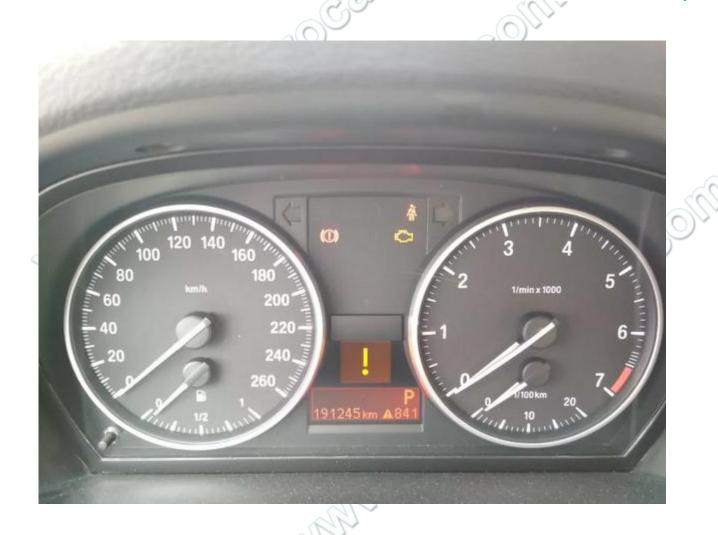
2. Record the original mileage.

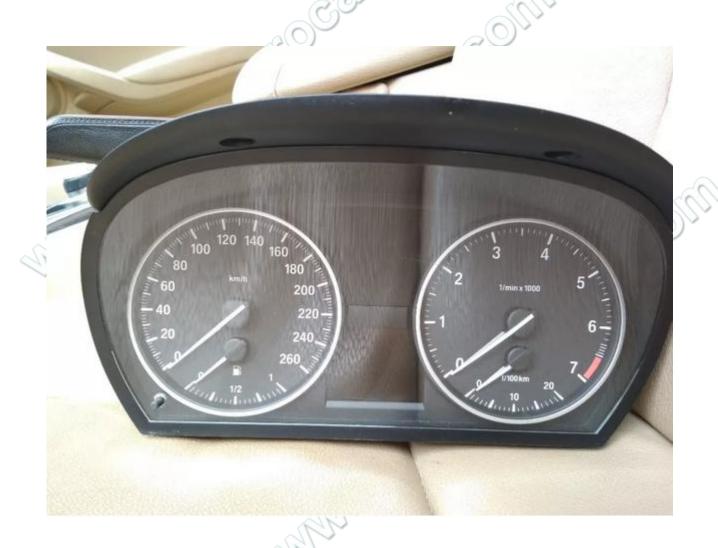
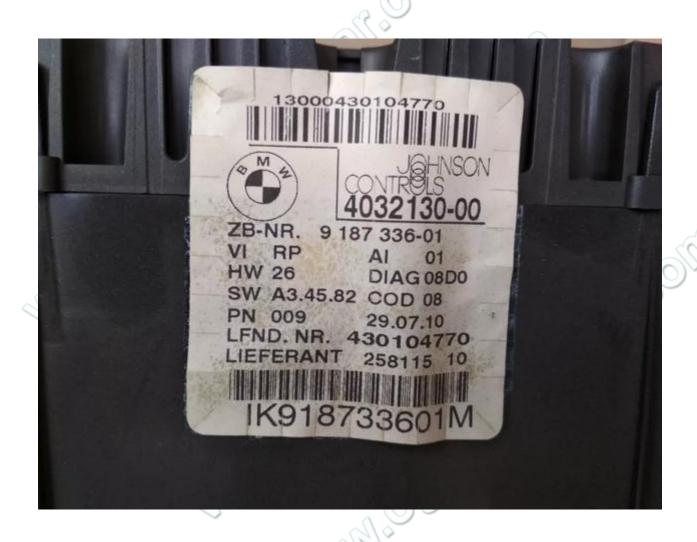
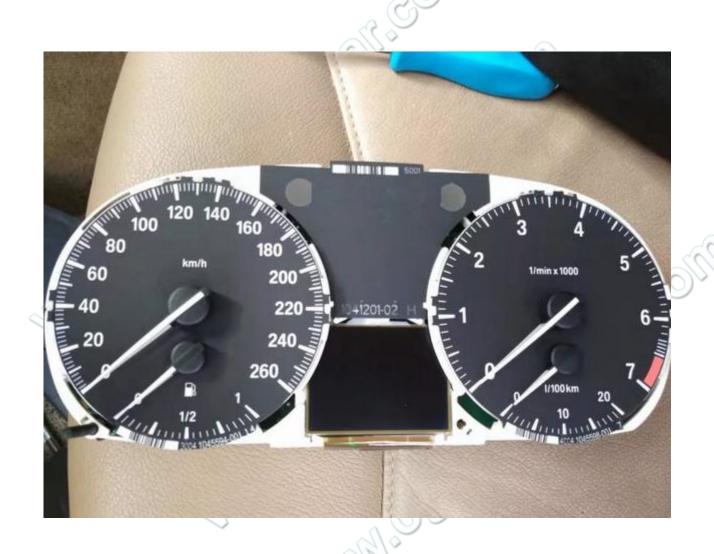
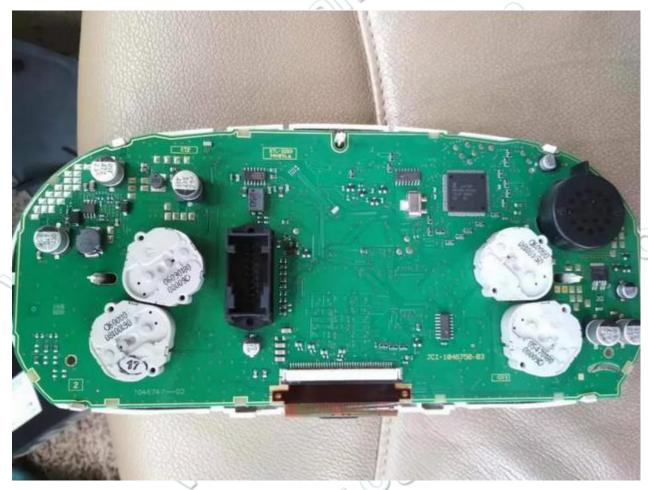
3. The vehicle power off, remove the instrument module, view the style, determine the storage chip.

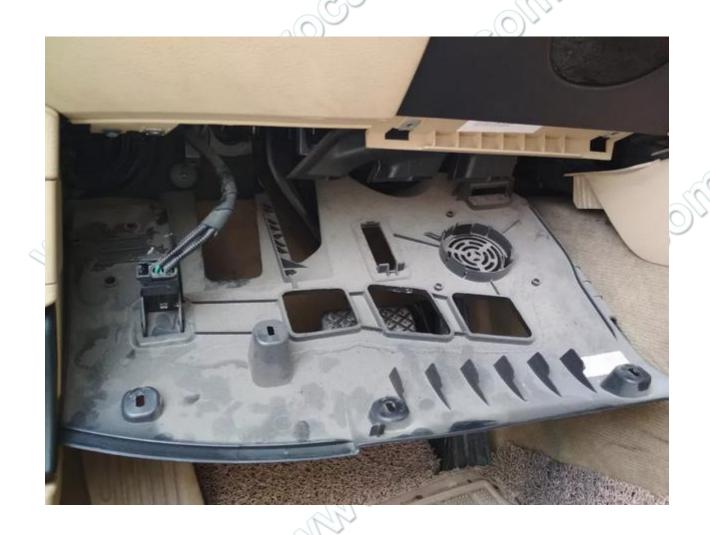
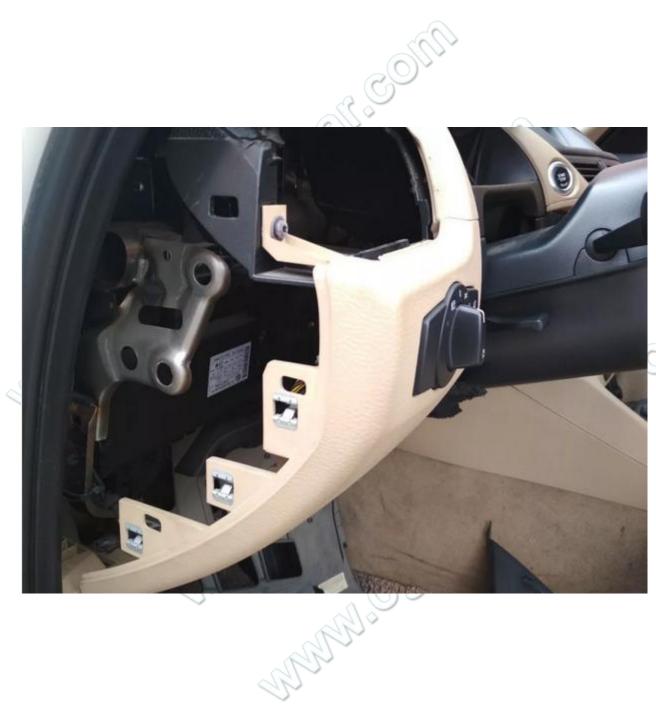
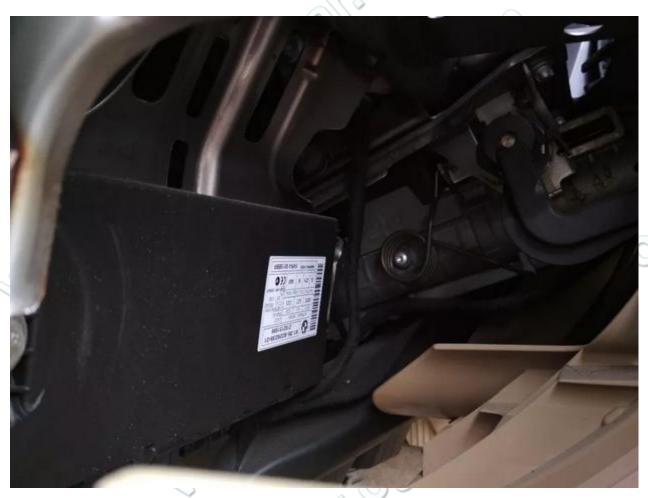
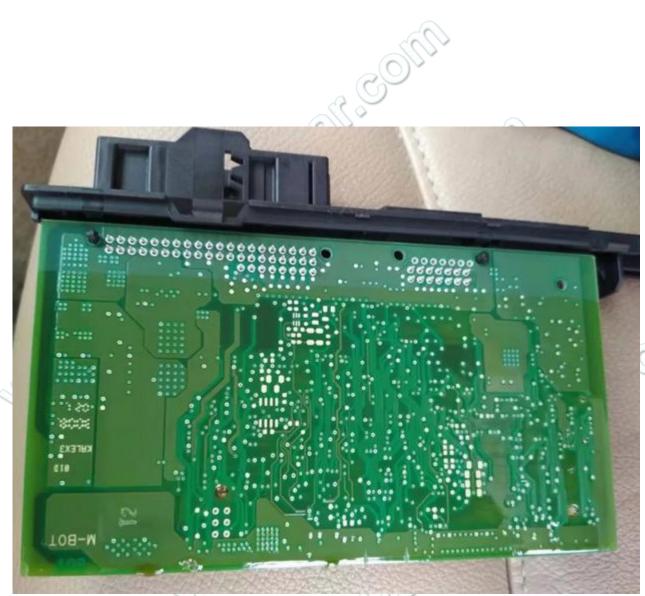
4. Remove the CAS module, view the style, and determine the storage chip.

61.35-9226238-01 2102151696 CAS 3 8MW AG D-80786Munchen FCC ID KRSCAS3 FC\_267T - CAS3 Software, Version 00.00.00 2.5.7 3.3.0 HW/5W-/Cod-/Diag-Index E30116RI - 000003 C4 20.5 06A0 CEC SIEMENS VOO 5WK4 9515BBR

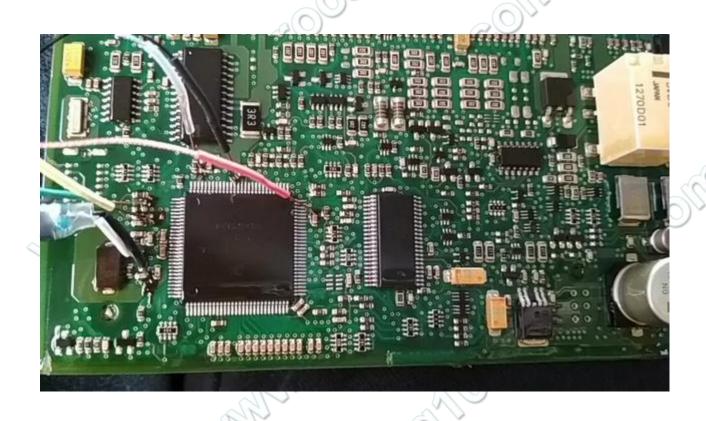
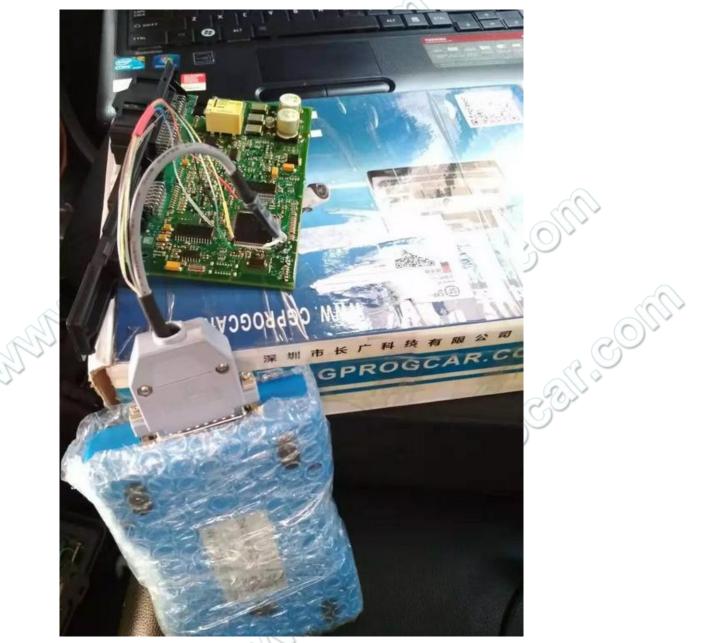
6. Clean the glue on CAS module, use DB25 adapter wiring, and repair it into target mileage.

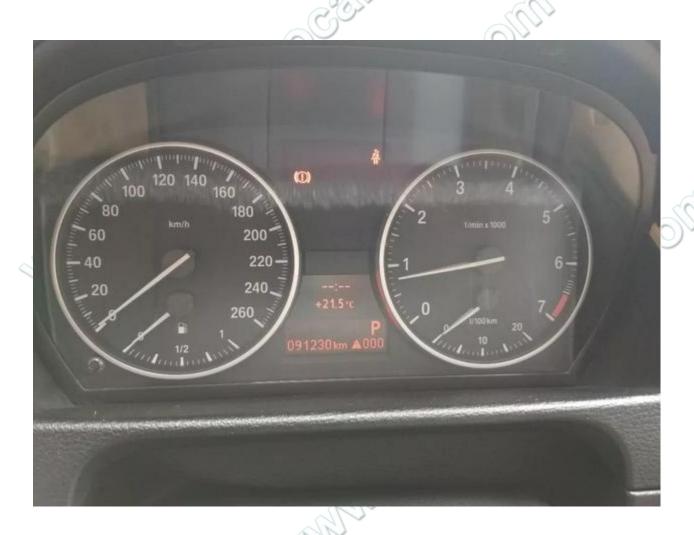
7. The instrument panel and CAS have been processed and loaded. Some will appear fault code, clear code can; Some will display English, using CGDI will be the instrument code.
